## **ANALYSIS OF THE CAUSES AND CONSEQUENCES OF RESONANCE ACCIDENTS IN BLAST FURNACES**

**Purpose.** *To determine the actual mechanism of the explosive destruction of Blast Furnace No. 7 at the Dniprovsky Metallurgical Plant (DMP) on September 7, 1993, taking into account both objective and subjective contributing factors.*

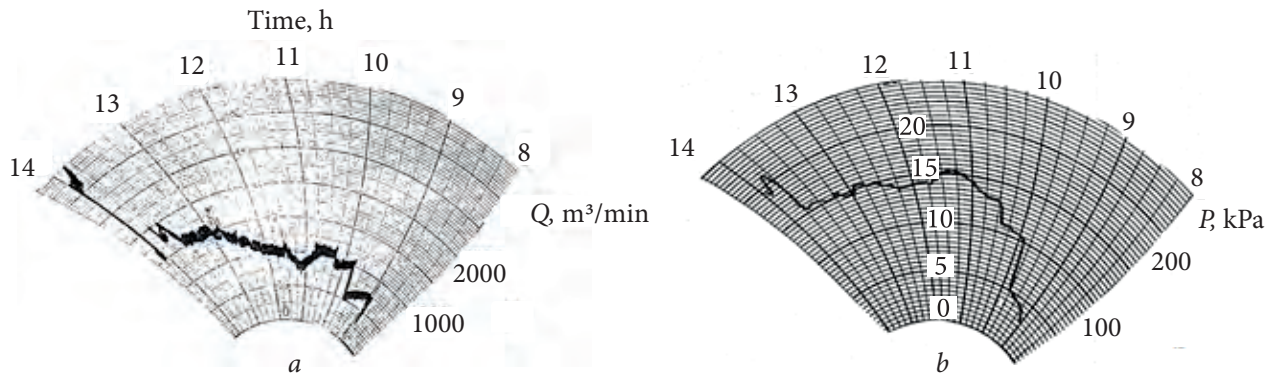
to 1100 m<sup>3</sup>/min, leading to a rise in the hot blast overpressure (Fig. 1, b) and the lower pressure drop (Fig. 2, b). Later, to reduce this pressure drop, the blast air flow rate was decreased by approximately 350 m<sup>3</sup>/min. As a result of this reduction and the opening of the tap hole at 11:00 AM, the lower pressure drop decreased. Reasonably, Commission 2 interpreted this reduction as an indication of burden settlement in the lower part of the furnace. In our opinion, this settlement, along with the degradation of the coke “windows” above the settlement level and burden sintering, led to the formation of the first cavity (Fig. 3, item 7), which should have been immediately eliminated through a controlled burden settlement.

**Fig. 1.** Fragments of circular diagrams showing the cold blast flow rate after the snort valve (a) and the hot blast overpressure (b) during the blow-in period of BF No. 7 at DMP on 07.09.1993

nace top and the increase in the upper pressure drop (Fig. 2, *a*), initiated blast rate intensification (Fig. 1, *a*). As a result, by 1:30 PM, the blast air flow rate reached 1500 m<sup>3</sup>/min.

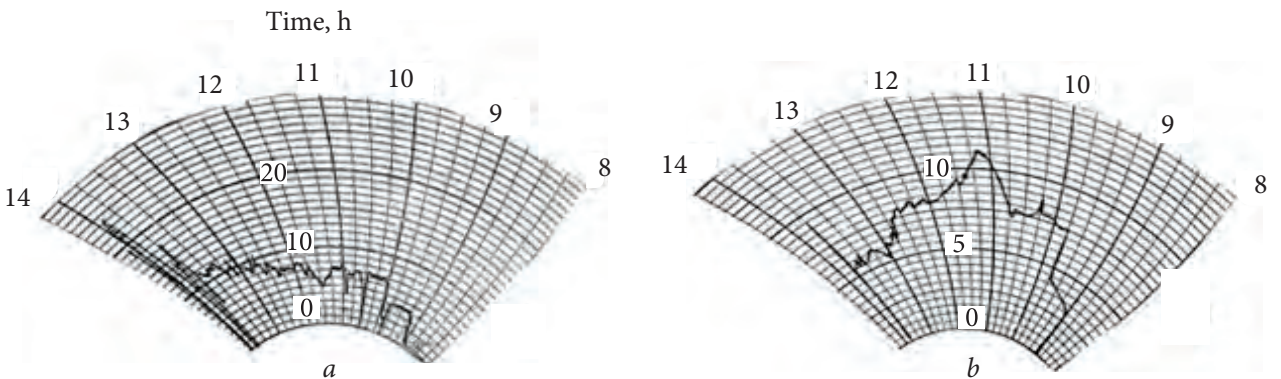
**Fig. 2.** Fragments of circular diagrams of the upper (a) and lower (b) gas pressure drops during the blow-in period of BF No. 7 at DMP on 07.09.1993

In addition to the sharp increase in the upper pressure drop (Fig. 2, *a*), the presence of the accretion was indicated by the temperature dynamics of the top gas when the working burden, moistened by 9 t of condensate (according to IChM calculations), was released from the large bell (LB) at 1:40 PM. After the bell was lowered, the temperature dropped from 500 °C to 250 °C and then rose to 475 °C within 12 minutes.

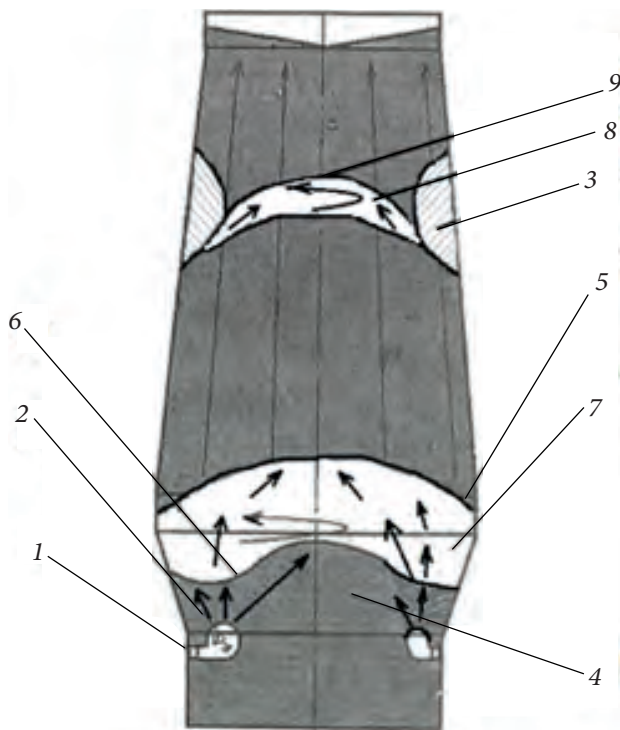
**Fig. 3.** Scheme of cavity formation in the column of burden materials during the first hours of the blow-in period of BF No. 7 at DMP on 07.09.1993: 1 — tuyeres; 2 — tuyere raceways; 3 — cooling zone; 4 — coke packing; 5 — upper boundary of the lower cavity; 6 — lower boundary of the lower cavity; 7 — lower burden cavity; 8 — upper burden cavity; 9 — upper boundary of the lower cavity

The first medium-strength explosion occurred during the lowering of the large bell (LB) and the explosive steam generation in the upper furnace cavity (Fig. 3, item 8) as a result of the interaction of water drained from the cone with furnace gases and heated materials. The force of the first explosion, directed upwards, caused the opening of the atmospheric valves on the furnace gas ducts, ripped open the hatches on the inclined gas ducts, and destroyed the dust catcher dome, ejecting the shutoff valve over a considerable distance.

The rupture of the charge, initiated by the first explosion, led to a powerful “lower” explosion in the cumulative cavity (Fig. 3, item 7). The second explosion was much more powerful than the first due to the interaction of larger amounts of water with heated materials and gases, higher temperatures, and the existence of a large cumulative chamber (up to 250 m<sup>3</sup>) in the area of the softening zone, which resulted in detonation.

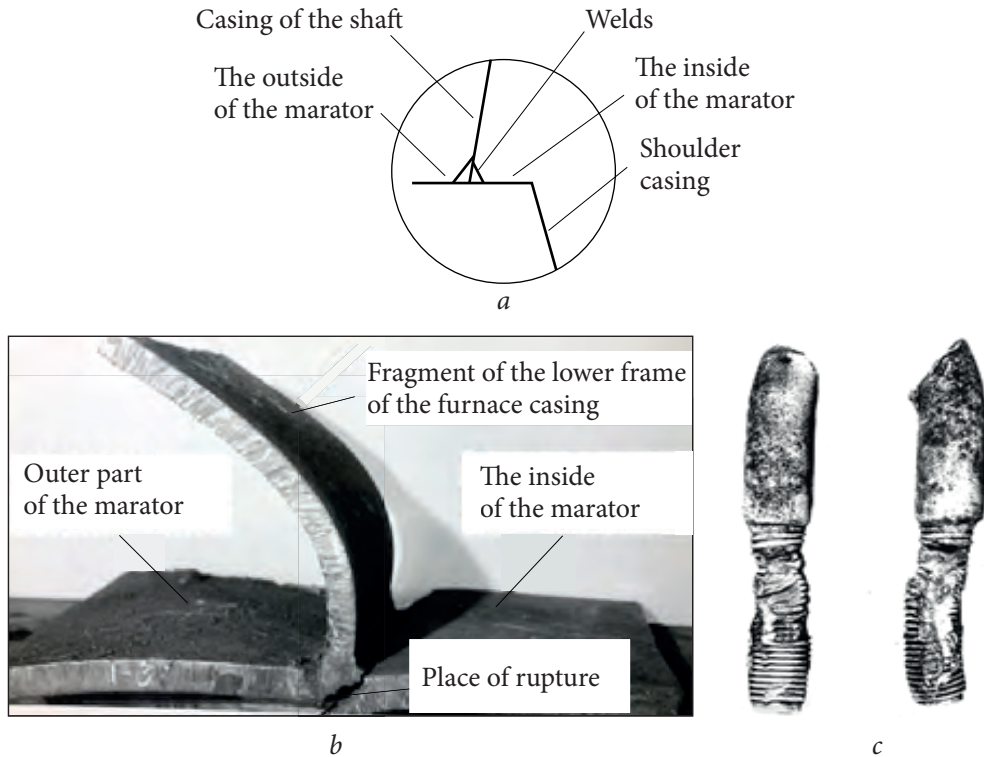
**Fig. 4.** Scheme of the deck ring assembly (a), sample for the study of the condition of the deck ring (marator) and shaft casing (b), taken at BF No. 7 DMP during disassembly, and the nature of the bolt destruction connecting the deck ring with the blast furnace column head (c). Samples were taken at BF No. 7 DMP during the disassembly of metal structures

contains two fragments with a gap between them — on the left, an intact outer part of the deck ring and shaft casing, and on the right, the inner (furnace) part of the marathon ring. The study showed that the deck ring was made of steel grade 09Г2С, according to the requirements of GOST 19281-89, and the casing was made of steel grade 15X-20X, according to GOST 4543-71.

It was established that the macrostructure and microstructure of the deck ring metal and the furnace casing at BF No. 7 were of satisfactory quality, and the weld seam connecting the ring with the casing was not destroyed.

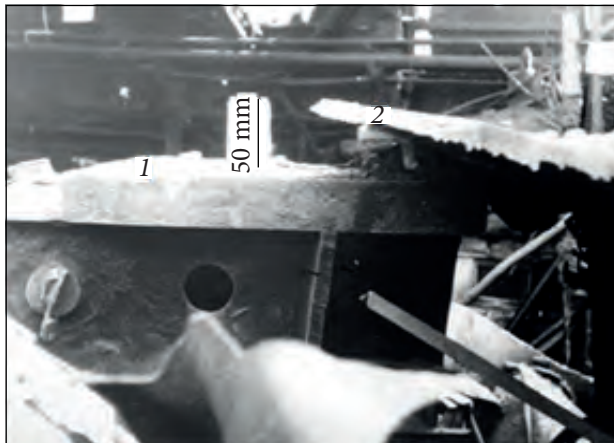
**Fig. 5.** Character of deformation of the inner part of the deck ring (marator) in the section not deformed by the shaft's fall: 1 — furnace column head; 2 — fragment of the inner part of the deck ring (marator) lifted above the column head

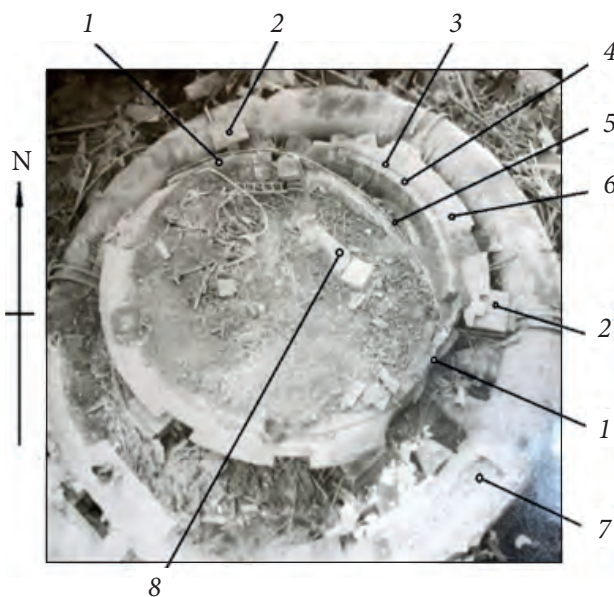
As seen in Fig. 6, the aforementioned displacement of the shaft relative to the axis of the blast furnace occurred as a result of the shaft falling from a certain height due to the force of the explosion. The photo clearly shows the areas where

**Fig. 6.** General view of the metal structures of BF No. 7 during the dismantling of the lower part of the furnace: 1 — location of the boshes destruction due to the falling of the stamp; 2 — furnace column heads; 3 — boshes casing; 4 — boshes coolers; 5 — shaft casing; 6 — remnants of the internal part of the deck ring (marator) with cutouts for metal condition analysis; 7 — ring air duct; 8 — small cone, removed during furnace dismantling

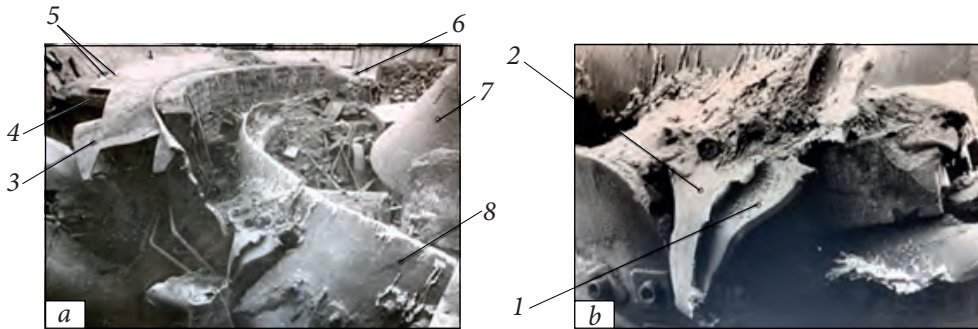
the falling shaft cut through the inner part of the marator. Figure 7 shows the scale of the damage to the boshes and the shaft itself during its fall.

**Fig. 7.** General view of the destruction site of the boshes of BF No. 7 by the falling shaft (a) and a close-up fragment of this site (b): 1 — fragment of the crushed inner part of the deck ring; 2 — casing of the lower part of the shaft; 3 — inner part of the deck ring (marator) with cut-outs for research; 4 — head of the furnace column; 5 — bolt heads fastening the deck ring (marator) to the columns; 6 — place of destruction of the top of the boshes by the falling shaft from the southeast side; 7 — small cone of the charging device; 8 — remains of the casing of the shaft during disassembly

boshes, but by the explosion lifting the furnace casing with the metal structures to a certain height, resulting in the loss of the casing’s function as the core of the structural rigidity of the central furnace unit [16, 17].

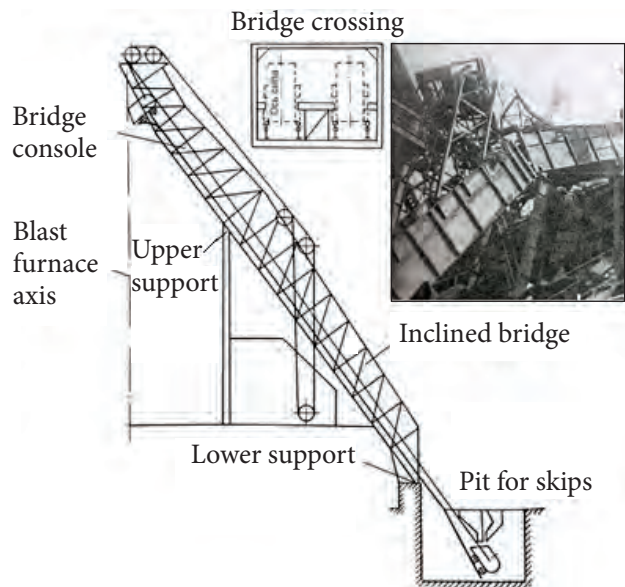
The nature of the damage to the inclined bridge of the skip hoist also indicates significant movement of the blast furnace structure during the explosion upwards. Earlier (M.S. Shchyrenko, *Mechanical Equipment of Blast Furnace Shops*, 1962), three-support bridges were built, where the upper support was placed on the furnace bosh, the middle support on the frame column (pylon), and the lower support on the skip pit wall. The pylon was made in the form of a flat truss that had flexibility along the longitudinal axis of the bridge. Three-support bridges were affected by the deformation of the blast furnace casing, which is why modern furnaces are equipped with two-support bridges (Fig. 8, a): the upper support is placed on the pylon, and the lower support is placed on the skip pit wall [15]. Due to the lack of a rigid connection between the console and the metal structures of the furnace shell, minor deformations of the furnace casing, such as those caused by gas explosions during blowouts, did not result in damage to the inclined bridge.

During the powerful explosion, the movement of the furnace along with the stamp upwards caused a violent impact that lifted the bridge console, which, when falling onto the pylon, bent it in the direction of the blast furnace. As a result, the inclined bridge was destroyed at the assembly joint (Fig. 8, b) [1, 12]. The rupture of the assembly joint was facilitated by the destruction of the stamp and the bosh platform, on which the console was supported. It is likely that the tilt of the furnace casing in the southeast direction at the moment of the explosion caused the shock from the destruction of the inclined bridge, and the existence of a temporary connection between the tuyere gas ducts and the dust collector through the descending gas ducts.

**Fig. 8.** Scheme of a two-support inclined bridge skip hoist (a) and the inclined bridge destroyed during the explosion of Blast Furnace No. 7 (b): photo from [12]
